Daily Field Reports

Project Title: McCormick and Baxter Upland Cap
E & E Project No.: 001688.OY14.25.03

Client: ODEQ

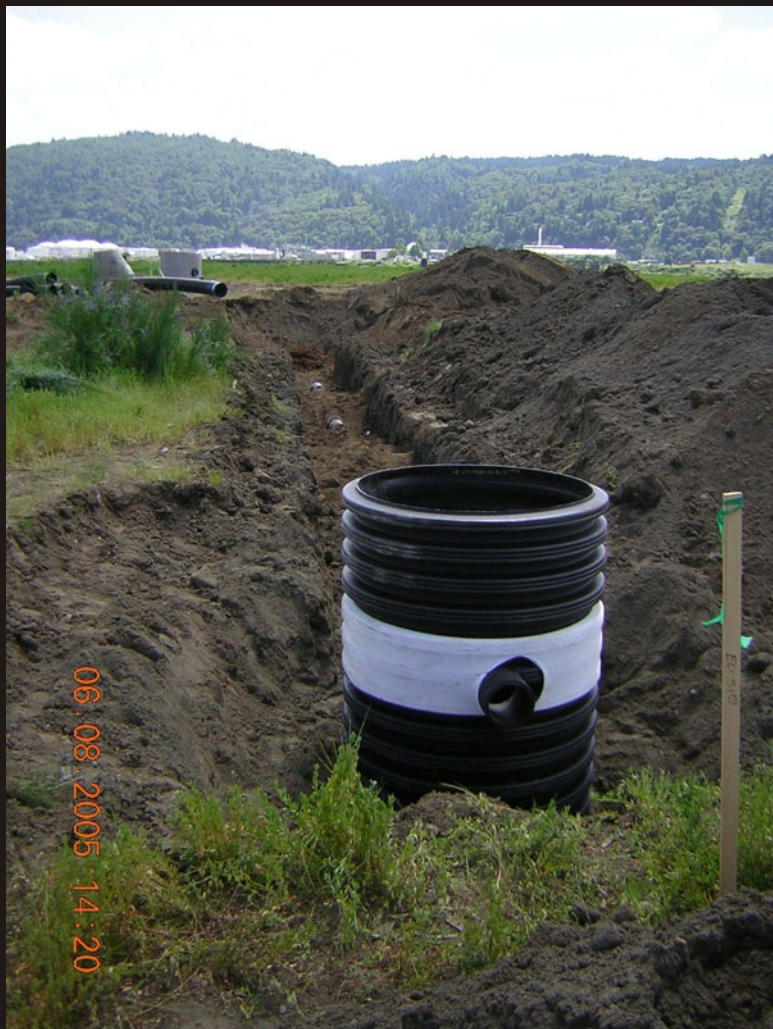
Photo 8 Manhole D with a partially installed pipe to Manhole E.

06.08.2005 14:20

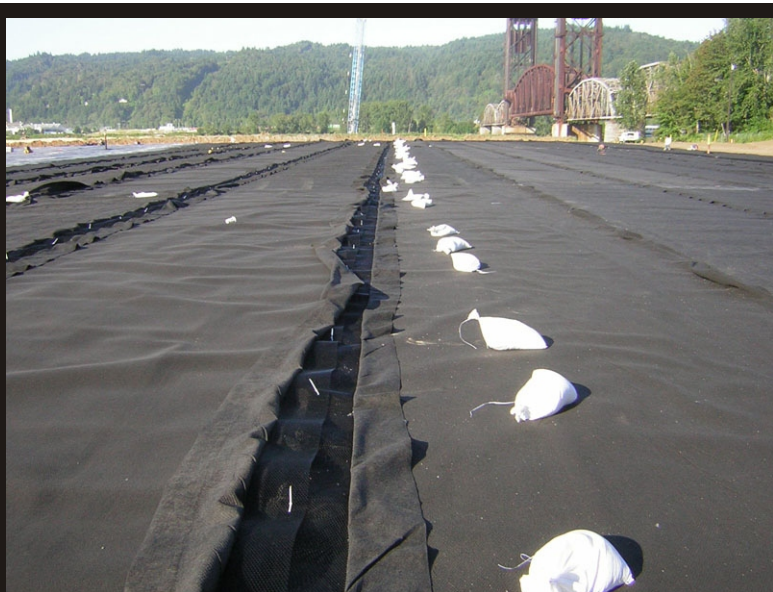
Photo 30 Seams of geocomposite zip-tied together (left), and seams after they've been heat-tacked (right).

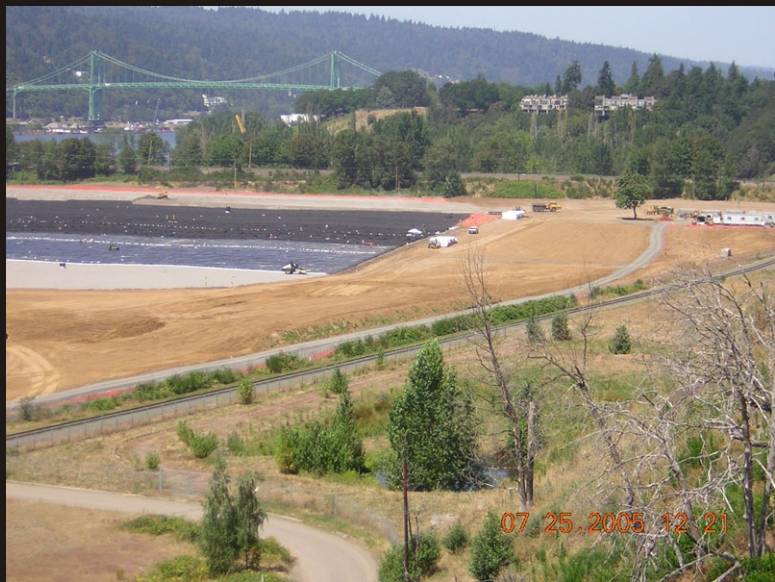
Photo 32 Overview of site showing four layers of impermeable cap. Starting from the foreground: sand leveling layer, geomembrane layer, geocomposite layer, and drainage sand layer.

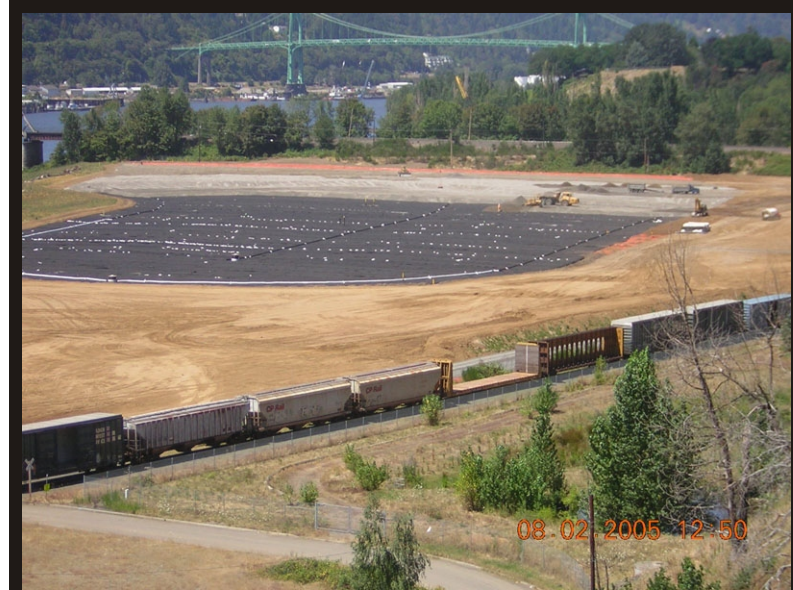
Photo 35 Overview of site showing three layers of impermeable cap. Starting from the foreground: geocomposite layer, drainage sand layer, and 4" minus biotic rock layer.

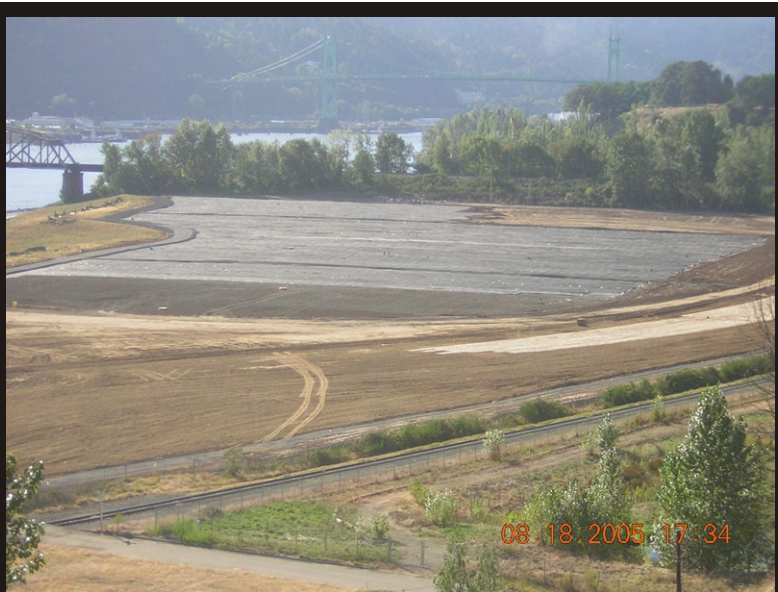
Photo 40 Overview of site showing three layers of impermeable cap. Starting from the foreground: 4" minus biotic rock, geotextile, and topsoil.
